Postoperative radiograph of the hip arthroplasty: what the radiologist should know

Abstract This pictorial review aims to provide the radiologist with simple and systematic guidelines for the radiographic evaluation of a hip prosthesis. Currently, there is a plethora of commercially available arthroplasties, making postoperative analysis not always straightforward. Knowledge of the different types of hip arthroplasty and fixating techniques is a prerequisite for correct imaging interpretation. After identification of the type of arthroplasty, meticulous and systematic analysis of the following parameters on an anteroposterior standing pelvic radiograph should be undertaken: leg length, vertical and horizontal centre of rotation, lateral acetabular inclination, and femoral stem positioning. Additional orthogonal views may be useful to evaluate acetabular anteversion. Complications can be classified in three major groups: periprosthetic lucencies, sclerosis or bone proliferation, and component failure or fracture.

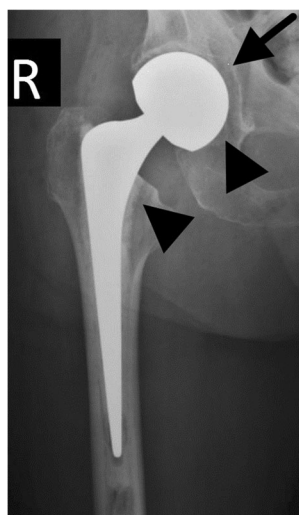
Fig. 1 Anteroposterior (AP) radiograph. Cemented unipolar hemiarthroplasty. The femoral stem with the fixed head (*arrowheads*) articulates with the native acetabulum (*arrow*)

In a hemiarthroplasty, the acetabulum is spared whereas the femoral head and neck are replaced. This type of prosthesis is indicated when the native acetabulum is unaffected. A unipolar hemiarthroplasty consists of a femoral stem with a fixed head, which articulates with the native acetabulum (Fig. 1). A bipolar

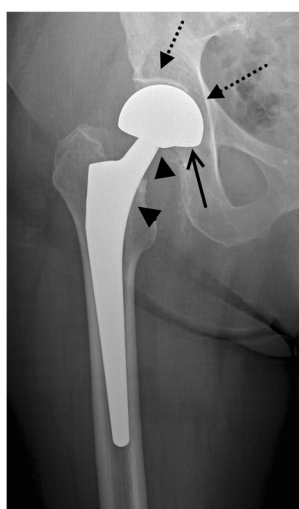
Fig. 2 AP radiograph. Cementless bipolar hemiarthroplasty. The femoral stem with a fixed head (*arrowheads*) articulates with a polyethylene lined metal cup (*arrow* indicates position of the radiolucent polyethylene), which articulates with the native acetabulum (*dotted arrow*)

hemiarthroplasty consists of a femoral stem with a fixed head and a polyethylene lined metal cup, accommodating motion between the cup and the prosthetic head as well as between the cup and the native acetabulum (Fig. 2). In a resurfacing hemiarthroplasty, only the femoral head is replaced (Fig. 3).

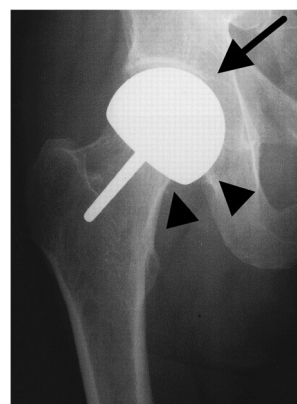
Fig. 3 AP radiograph. Cementless resurfacing hemiarthroplasty. Only the femoral head is replaced (*arrowheads*), which articulates with the native acetabulum (*arrow*)

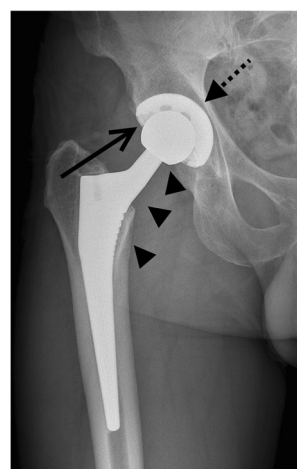
Fig. 4 AP radiograph. Cementless total hip arthroplasty. In a total hip arthroplasty, both femoral head and neck (*arrowheads*) as well as the acetabulum (*dotted arrow*) are replaced. The *open arrow* indicates the position of the radiolucent polyethylene cup at the articulation of the prosthetic femoral head and the acetabulum

In a total hip arthroplasty both the femoral head and neck as well as the acetabulum are replaced (Fig. 4). In a resurfacing total hip arthroplasty, the femoral head and acetabulum are replaced, whereas the femoral neck is spared (Fig. 5).

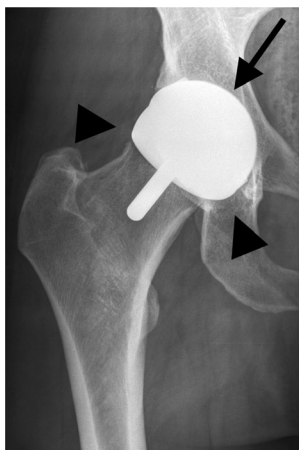
Fig. 5 AP radiograph. Cementless resurfacing total hip arthroplasty. In a resurfacing total hip arthroplasty, the femoral head (*arrowheads*) and acetabulum (*arrow*) are replaced. No radiolucent area at the femoral head—acetabulum is noted (metal—on—metal bearing surface)

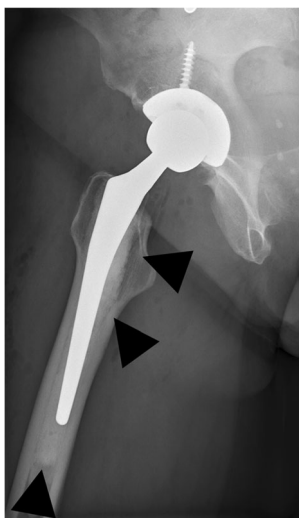
Fig. 6 AP radiograph. Cemented total hip arthroplasty, single acetabular screw fixation. In a hybrid cemented arthroplasty, the femoral stem is fixed with cement (*arrowheads*)

Bone cement consists of a mixture of an acrylic cement and additives, including Barium (or Zirconium) to render it radio-opaque. Hybrid arthroplasty is a combination of a cemented femoral stem and a cementless acetabular cup, whereas in a reverse hybrid arthroplasty a cementless femoral stem and a cemented acetabular cup are used (Figs. 6 and 7) [5].

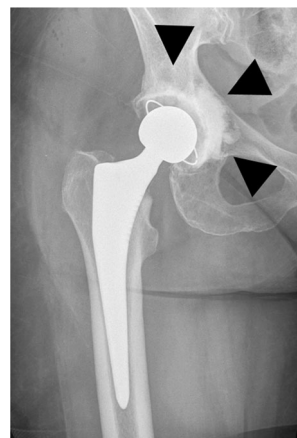
Fig. 7 AP radiograph. Cemented total hip arthroplasty. In a reverse hybrid cemented arthroplasty, the acetabular cup is fixed with cement (*arrowheads*)

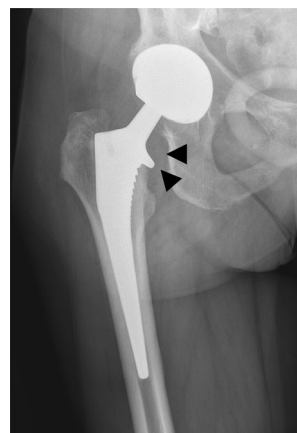
Fig. 8 AP radiograph. Cementless total hip arthroplasty. *Arrowheads* indicating the collar of this collared femoral stem

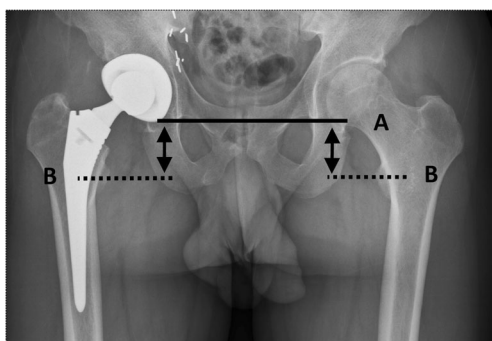
Fig. 9 The leg length is measured as the distance between line A (connecting the undersurface of the acetabular tear drops) and line B (through the middle of the lesser trochanter)

The leg length (Fig. 9) is measured by drawing a line transversely connecting the inferior borders of the acetabular tear drops, the pelvic reference line. The lesser trochanters are used as the femoral reference lines. Perpendicular lines are drawn from the pelvic reference line to the femoral reference lines, the difference between the distances being the leg length discrepancy [8]. Leg length inequality is common after hip arthroplasty; a discrepancy of up to 1 cm is well tolerated. Moderate inequalities are usually corrected with a shoe orthosis.

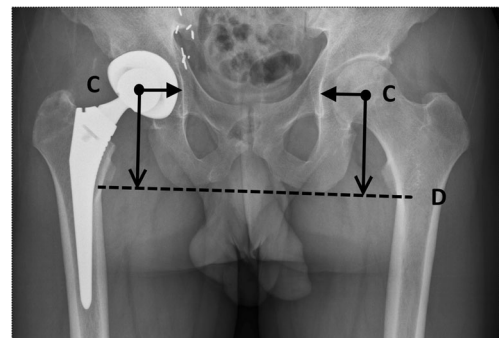
Fig. 10 The horizontal centre of rotation is defined as the distance between the centre of the femoral head (point C) and the lateral outline of the teardrop shadow. The vertical centre of rotation is defined as the distance between the centre of the femoral head (point C) and the transischial tuberosity line (line D)

The horizontal centre of rotation (Fig. 10) is defined by the distance between the centre of the femoral head and

the teardrop shadow. Ideally, this distance should be equal to that of the contralateral hip; excessive lateral positioning of the acetabular component increases the risk for dislocation and may cause limping.

The vertical centre of rotation (Fig. 10) is defined by the distance between the centre of the femoral head and the transischial tuberosity line. Ideally, this distance should be equal to that of the contralateral hip, mimicking normal anatomy.

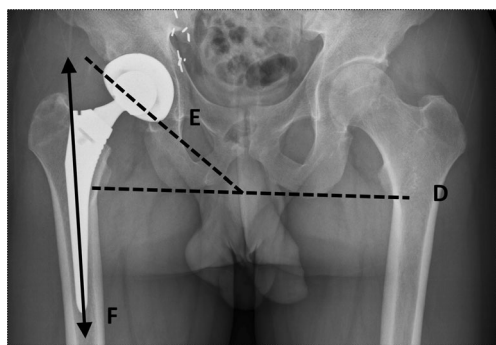
Fig. 11 The acetabular inclination is measured by drawing a line through the medial and lateral margins of the cup (line *E*) and measuring the angle with the transverse pelvic axis (line *D*). The femoral stem positioning should be aligned with the longitudinal axis of the shaft (line *F* = normal, longitudinal axis of the shaft)

The acetabular inclination (Fig. 11) is the angle between the articular side of the acetabular cup and the transverse axis. Measurement of this angle can be done by drawing a line through the medial and lateral margins of the cup and measuring the angle with the transischial tuberosity line. The normal range of inclination is between 30 and 50° [9]. Smaller angles provide a stable

Ideally, the position of the femoral stem (Fig. 11) on an AP view should be seen in neutral alignment with the longitudinal axis of the femoral shaft, and the tip situated in the centre of the shaft. Many studies have shown that failure of the femoral stem is associated with varus malpositioning [10–12]. The femoral

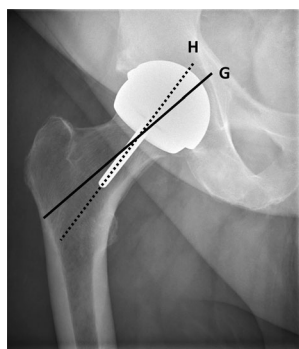
Fig. 12 Normal valgus positioning of the femoral stem in a resurfacing arthroplasty (line *H*) compared with the longitudinal axis of the femoral neck (line *G*)

component of a resurfacing arthroplasty should be placed in a relative valgus position of 5° – 10° (Fig. 12).

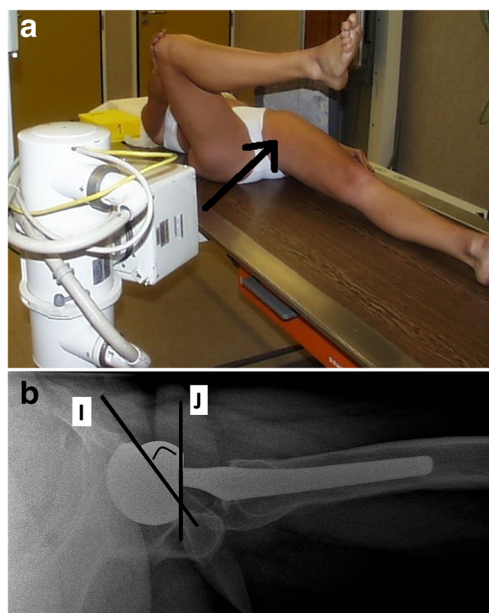
Fig. 13 **a** Photograph of the patient positioning for a lateral view of the hip, the *arrow* indicating the direction of the x-rays. **b** Lateral radiograph. The acetabular anteversion is defined by the angle between the acetabular axis (line *I*) and the coronal plane (line *J*). In this patient, the angle measures approximately 25° (normal range between 5°–25°)

The acetabular anteversion is defined on a lateral view by the angle between the acetabular axis and the

coronal plane (Fig. 13). Normal value ranges from 5° to 25° anteversion as this allows adequate flexion of the hip [13]. Acetabular retroversion predisposes to hip dislocation.

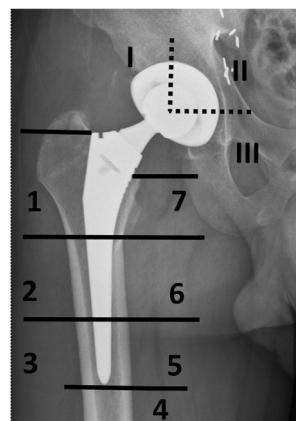
Fig. 14 Standardized template for radiographic assessment of periprosthetic lucency, with three acetabular zones (*I–III*) and seven femoral zones (*1–7*)

For localization of cement-related or periprosthetic abnormalities at the acetabular and femoral components, standardized templates have been described by Charnley-Delee [16] and Gruen [17], respectively (Fig. 14).

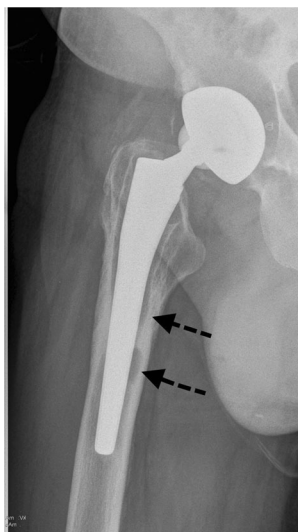
Fig. 15 AP radiograph, 3 years postoperatively. Cementless bipolar hemiarthroplasty. Aseptic loosening, radiographically seen as periprosthetic lucencies in a Gruen zone 5/6 (arrows)

Aseptic loosening or osteolysis (Fig. 15) is a biological process that is initiated by macrophage phagocytosis of particulate debris, causing an aseptic foreign body granulomatosis [18]. The implant becomes separated from the host bone, resulting in mechanical (aseptic) loosening. On a radiograph, this manifests as a periprosthetic zone of radiolucency around the bone-cement or the bone-prosthesis interface.

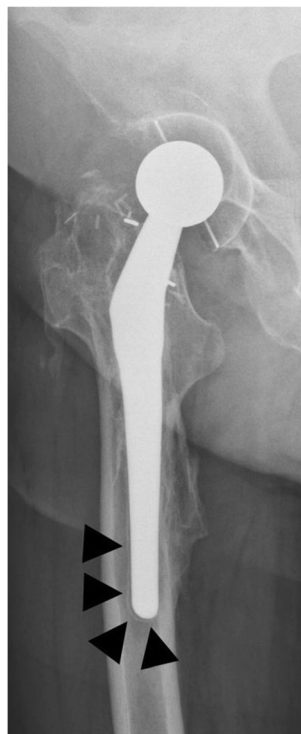
Fig. 16 AP radiograph. Cementless total hip arthroplasty. A < 2 mm lucency, outlined by a discrete sclerotic margin, in Gruen zone 3/4 (arrowheads): this indicates a fibrous rather than bony ingrowth, thought to provide sufficient stability

Aseptic loosening and osteolysis should be differentiated from other, nonpathological causes of periprosthetic lucencies. In a cemented arthroplasty, a < 2 mm lucency at the bone-cement interface indicates the formation of a fibrous membrane (representing the lucency), outlined by a thin, sclerotic demarcation line [19]. This is thought to represent a stable fibrous reaction to cement. In a cementless arthroplasty, a similar < 2 mm lucency also outlined by a thin sclerotic line, along a polished segment where no bony ingrowth is expected, indicates fibrous bony ingrowth and is thought to provide sufficient stability (Fig. 16) [20].

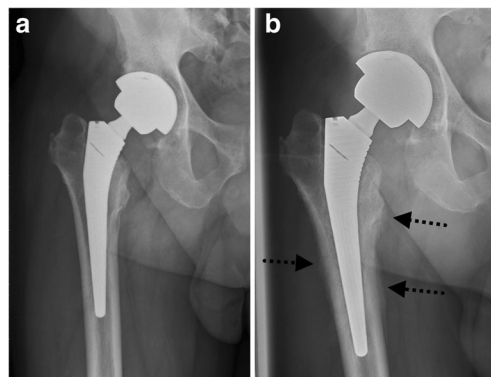
Fig. 17 **a** AP radiograph, 1 month postoperatively. Cementless total hip arthroplasty. Normal postoperative findings. **b** AP radiograph of the same patient, 3 months postoperatively. Periprosthetic reaction in Gruen zone 2/5/6/7 (arrows): proven case of infection

aseptic loosening can be very challenging, especially when no previous radiographs are available. However, the presence of a femoral periosteal reaction [22] (Fig. 17) or rapid progressive disease [23] (Fig. 18) are indicative of septic rather than aseptic loosening.

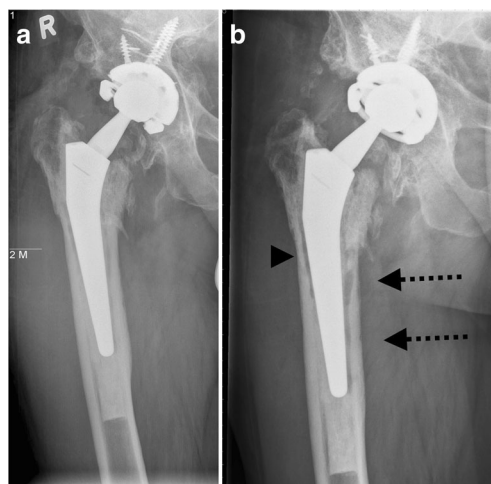
Fig. 18 **a** AP radiograph, 4 months postoperatively. Cemented (hybrid) total hip arthroplasty after revision with acetabular fixation screws. Normal postoperative findings. **b** AP radiograph of the same patient, 5 months postoperatively. Periprosthetic lucencies in Gruen zone 5/6 (arrows) and more discrete in Gruen zone 2 (arrowhead): proven case of infection

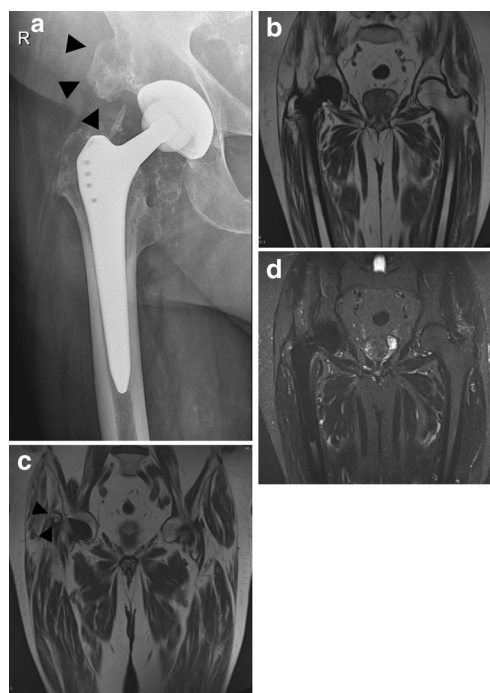
Fig. 20 Although current state-of-the art MRI with Metal Artefact Reduction Sequences allows assessment of correct position of the hip prosthesis as well as periarticular abnormalities, mature heterotopic bone formation (*arrowheads* in *A* and *C*) is often more readily visible on plain radiographs than on MRI due to similar signal of mature bone marrow and fatty infiltration within the gluteus musculature at the site of the hip prosthesis. **a** AP radiograph. Cementless total hip arthroplasty. Heterotopic bone formation (*arrowheads*), 7 years postoperatively. **b** T1-weighted, coronal image (WI) of the pelvis in the same patient. **c** T1-weighted, coronal image (WI) of the pelvis at a more anterior location barely showing heterotopic bone formation (*arrowheads*). **d** STIR, coronal image of the pelvis in the same patient

Development of bone outside its normal location in the skeleton is termed *heterotopic bone* formation, occurring in up to half of patients; this rarely results in significant limitation of movement (Figs. 20 and 21) [28].

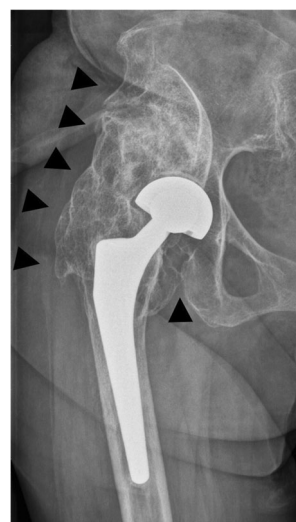
Fig. 21 AP radiograph. Cementless bipolar hemiarthroplasty. Extensive heterotopic bone formation (*arrowheads*), bridging from femur to pelvis, restricting abduction

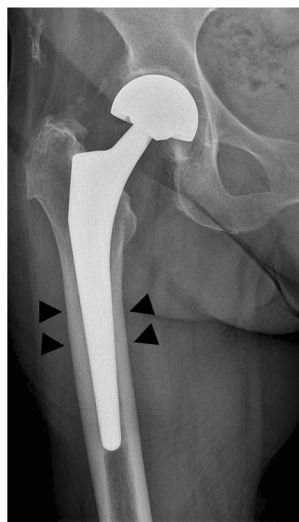
Fig. 22 AP radiograph. Cementless bipolar hemiarthroplasty. Spot welding (new bone formation originating from the endosteal surface and reaching the prosthesis) in Gruen zone 2/6 (arrowheads)

Spot welding consists of new bone formation originating from the endosteal surface and reaching the prosthesis. This is mostly seen in cementless femoral stems and is a strong indicator of stability (Fig. 22) [29].

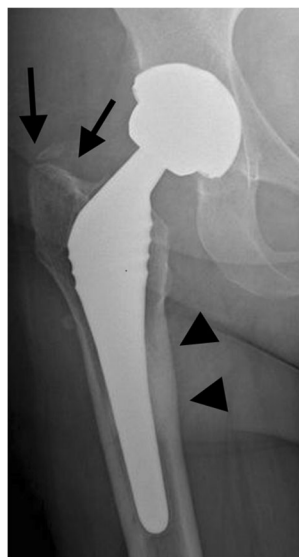
Fig. 23 AP radiograph. Cementless total hip arthroplasty. Stress shielding. Cortical hypertrophy in Gruen zone 1 (arrowheads) and adaptive atrophy in Gruen zone 6 (arrows) as different parts of reactive bone remodelling

Stress shielding refers to the transfer of the normal load from the femoral neck and intertrochanteric region to the proximal femoral diaphysis (the hip implant causes altered mechanical forces), causing bone resorption on the lateral side of the proximal femur, most commonly seen in Gruen zone 1, as well as bone hypertrophy at the medial side of the proximal femur (Fig. 23). This process implies stability and should not be misinterpreted as a complication [30].

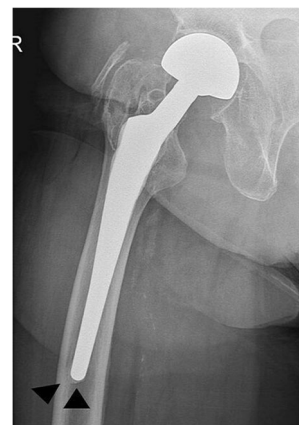
Fig. 24 AP radiograph. Cementless bipolar hemiarthroplasty. Bone pedestal in zone 4 (arrowheads). The association with loosening remains unclear

Sclerosis at the tip of a cementless femoral component, bridging the medullary canal, is a *bone pedestal* (Fig. 24). The association of this often incidentally found entity with loosening remains unclear [31].

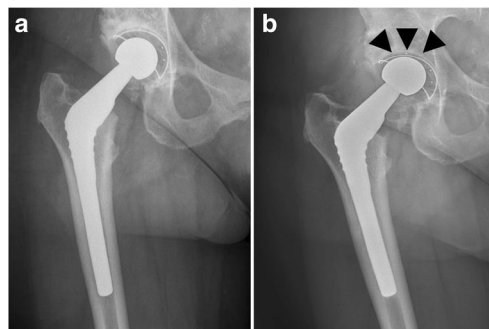
Fig. 25 **a** AP radiograph, 6 months postoperatively. Cementless total hip arthroplasty. Normal postoperative findings. **b** AP radiograph of the same patient, 4 years postoperatively. Cranial displacement of the femoral head in the acetabular cup (arrowheads), indicating linear wear

Linear wear occurs typically in hip arthroplasty with a polyethylene component (hard-on-soft or soft-on-soft bearing surface combination). An asymmetric position of the femoral head within the acetabular cup on radiographs is a definite sign of polyethylene wear (Fig. 25).

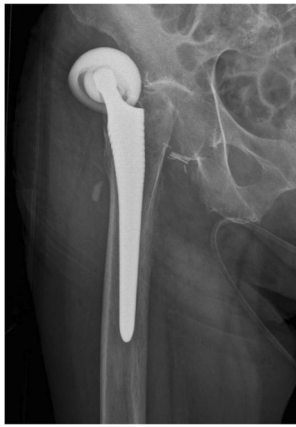
Fig. 26 AP radiograph. Cementless bipolar hemiarthroplasty. Lateral dislocation of head and acetabular cup

The reported rate of *dislocation* varies from 0.5 to 10 % after primary total hip arthroplasty [32]. Most dislocations occur in the early postoperative period, during the initial weight bearing (Fig. 26) [33]. Abnormal acetabular inclination, acetabular retroversion or an incorrect center of rotation, among others, increase the likelihood of dislocation.

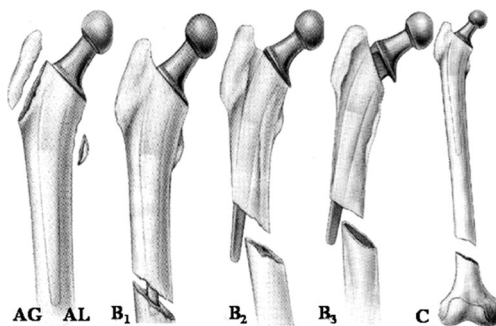
Fig. 27 Vancouver classification of periprosthetic fractures. *Type A* fractures are peritrochanteric fractures (subtypes *AG*: greater trochanter and *AL*: lesser trochanter). *Type B* fractures occur around or just below the tip of the femoral stem (subtypes *B1*: stable stem, *B2*: loose stem, *B3*: loose implant with substantial bone loss). *Type C* fractures occur well below the implant (image courtesy of Hwang KT, Kim YH (2011) Treatment of periprosthetic femoral fractures after hip arthroplasty. J Korean Fract Soc 24:121–130)

Periprosthetic fractures occur more often around the femoral than the acetabular component, be it intra- or postoperative. The Vancouver classification divides the periprosthetic, postoperative fractures of the femur into three major types (Fig. 27) [34]. Postoperative femoral fractures occur typically, but not exclusively, at the level of the tip of the femoral stem (Fig. 28).

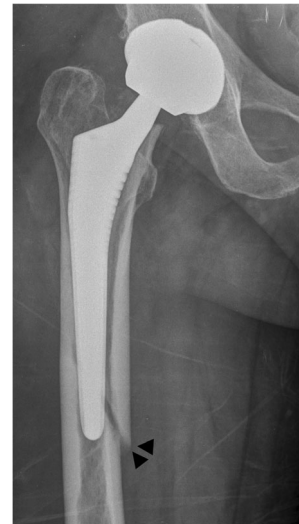
Fig. 28 AP radiograph. Cementless total hip arthroplasty. Periprosthetic fracture in Gruen zone 5 (arrowheads), Vancouver type B1 fracture

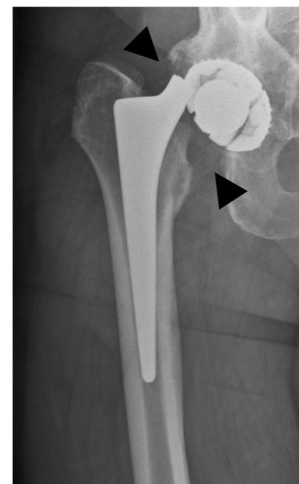
Fig. 29 AP radiograph. Cementless total hip arthroplasty. Proximal prosthetic/metallic fracture through the neck of the femoral implant (arrowheads)

Prosthetic fractures occur mostly in the femoral stem of the implant, representing a metal-fatigue stress fracture; this typically occurs in prostheses that are well fixed distally but are mobile proximally and result in fractures through the middle or proximal third of the stem (Fig. 29) [35]. Patients with increased body mass index (BMI) are at greater risk of reaching an implant failure point due to fatigue loading [36]. Varus malpositioning predisposes to fractures of the femoral stem.
